ENSURING PATIENT SAFETY IN THE NEW OPERATING THEATRE OF UMMC TRAUMA CENTRE; AN ANAESTHESIOLOGIST NOVICE EXPERIENCE

Mamat M¹, Chan L²

² Department of Anaesthesiology, Faculty of Medicine, Universiti Malaya, Kuala Lumpur

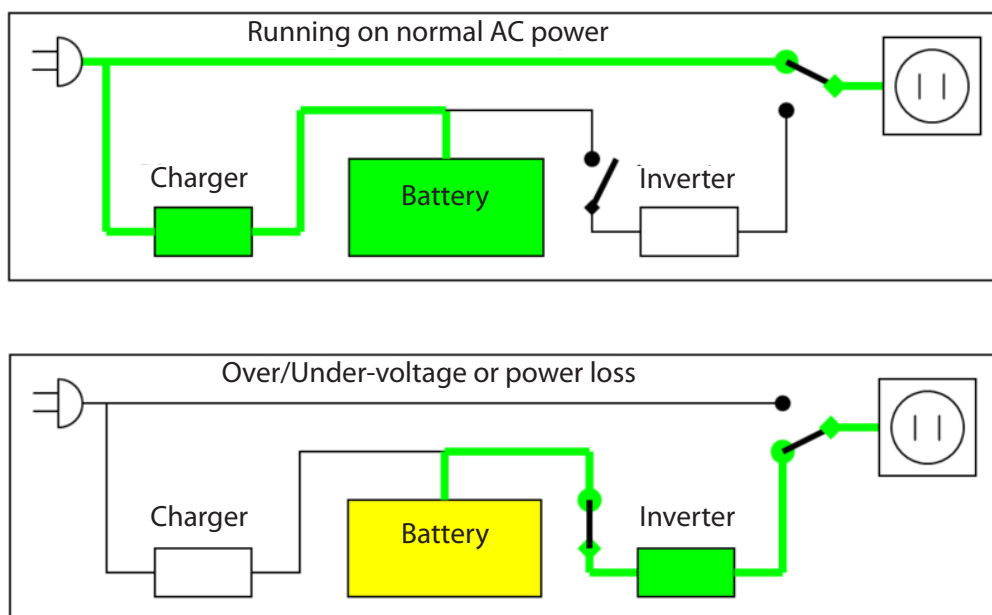
Figure 3: Simple, easy-to-understand diagram of how a Standby UPS works.

We were unable to objectively ensure electrical safety for both healthcare workers and patients according to international practice (6, 12). However, we were reassured by the UMMC electrical engineering team that all circuits were grounded and the hazard

of microshock was minimal. We were briefed regarding the Trauma Centre’s electrical safety backup (i.e. backup generator, UPS) in case of power failure. At all times in case of power failure from the main supplier, Tenaga Nasional Berhad, the trauma OT should always have adequate electrical supply by either the backup generator or the UPS system. (Figure 3)

On the 8 July, 2008, we experienced an “unintentional” blackout. It was here that we managed to identify the core electrical supply of the mini OT in the UMMC trauma centre. It was revealed later that the renovation work behind the trauma centre accidentally caused a main cable cut which was quickly repaired.

The OT lights were intermittently malfunctioning caused by the main supply wire. It was also noticed that few light bulbs were faulty. Emergency lights were obviously absent in certain parts of the complex. The UMMC Electrical division was notified and the necessary adjustments were performed immediately.
