Green Maintenance Approach: Low Carbon Repair Appraisal on St Paul's Church, Melaka, Malaysia

Brit Anak Kayan, Noor Suzaini Mohamed Zaid and Nurush Syhadah Mahmud*
Centre for Building, Construction, and Tropical Architecture (BucTA), Faculty of Built Environment, University of Malaya (UM), 50603 Kuala Lumpur, Malaysia

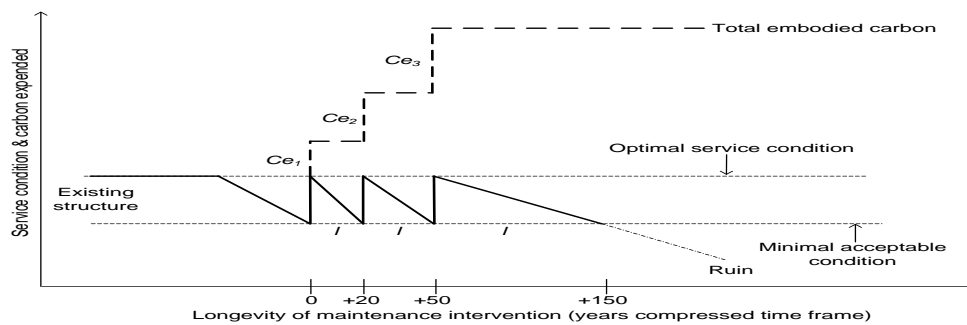
Figure 2: Relationship between longevity of repair and embodied carbon expenditure.
Source: Forster et al., (2011 and 2013), Kayan (2013)

Conceptually, Figure 2 sets out an insight on the relationship between each maintenance intervention that is characterised by its longevity (*l*) and embodied carbon expenditure (*Ce*) on the service graph condition. The downward sloping signifies the declining condition of the buildings over the life cycle of repair. Each maintenance intervention is important to keep the buildings at the optimal service condition and sustain the performance of the buildings, but it also contributes to CO₂ emissions (Blessing et al., (2015). Hypothetically, the more frequent of maintenance intervention, the greater embodied carbon expended (Forster et al., 2011 and 2013). Thus, 'Green Maintenance' gives the preference to the repair technique that has high longevity which incurred a lesser number of repeating interventions and number of

embodied carbon expenditure over the lifespan of the building.

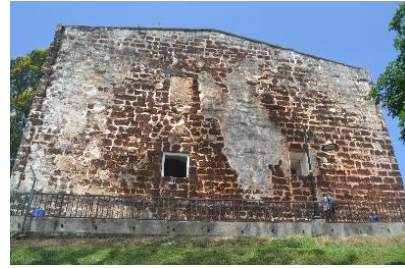
Figure 3: St Paul's Church

St Paul's Church is the oldest European building in Southeast Asia located on the summit of St Paul's Hill or known as Bukit Melaka, representing a network of Portuguese, Dutch and British colonials (Figure 3). First built in the-1560 by Duarte Coelho and enlarged by Jesuits using laterite block as the main building material. A glance at the physical appearance as it exists today clearly explains the different timelines of construction. It comprised thicker wall as indicative of the additional strength need to support an upper floor and high towers, a hundred feet tall to its pyramidal roof and reinforced at ground level with a central pillar (Tan, 2015).

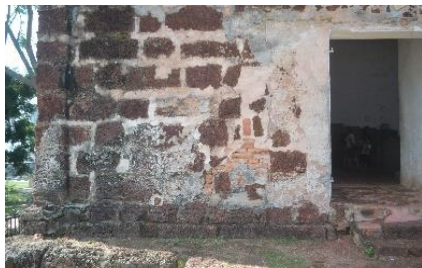
Figure 8: Usage of brick for stone replacement

Based on Figure 7, stone replacement is a repair involves in the serious decayed stonework. It is necessary to dig out the decayed stone, replace it with the matching one (Hyslop, 2006). In this case, it is found that bricks were alternatively used for replacement of laterite stones (see Figure 8). Technically, it requires cutting back of approximately 100mm of the defective material and building in a new section of stone (Forster et al., 2011). Practically, there will be a limited choice for replacement and the new stone need to undergo some complex process such as quarrying, extracting, processing and transporting that may be incurred high-energy usage, which contributes to high-embodied carbon (Hu and Wang, 2006), despite adoption of green reconstruction of the existing buildings (Hu and Wang, 2016). But, the life expectancy of 100 years may lead less maintenance intervention in a study period.

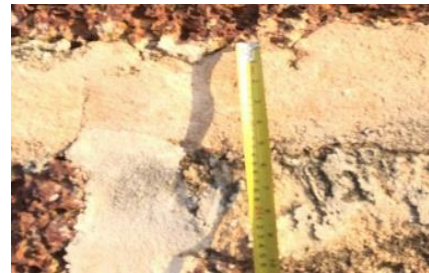
Figure 9: Pointing technique, 50-100mm of thickness

Repointing is the most common technique to repair loose open, crumbly and washed-out bedding and jointing mortar of wall (Dore et al., 2013) (see Figure 9). Normally, the mixture consists of binders, sand or is available in a pre-mixed form. Dealing with defect and decay, repointing requires cutting out failed joint mortar (removal of at least $\frac{3}{4}$ of an inch deep old mortar) and applying new mortar for finishing in order to replicate the original mortar style (Durnan and Muir, 2006). The rule of thumb is if there is more than 25% of the wall that needs to be repointed, it is effective to repoint the entire wall structure and applying the correct tool such as thin chisel or pointing tools with skilled craftsmen (Historic Scotland, 2007). The new material should be tooled to mimic the old joint profile in terms of visual and performance of structure and repointing in excessively hot, cold or rainy conditions should be avoided (Foulks, 1997). Besides, durability of repointing will depend on two factors such as

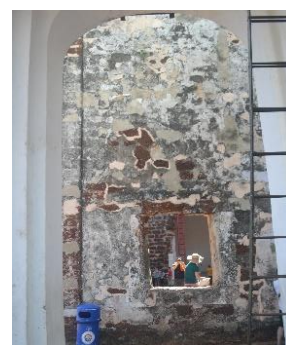
Figure 10: Mortar patch over the laterite surface

Commonly, plastic repair involved in serious decayed stonework related to the surface area that also known as mortar repair (Ashurt and Ashurt, 1988). Typically, the decayed stone needs to be cut back and lime-based mortars are applied to the surface of stone (Hyslop, 2006). In this case, this technique is limited to plastering and patching purpose (see Figure 10). The longevity of this technique is generally last for only 30 years and reapplied every 30 years periodically (3.33 times in the study period)(see Figure 7) (Forster et al., 2011 and Kayan, 2013).

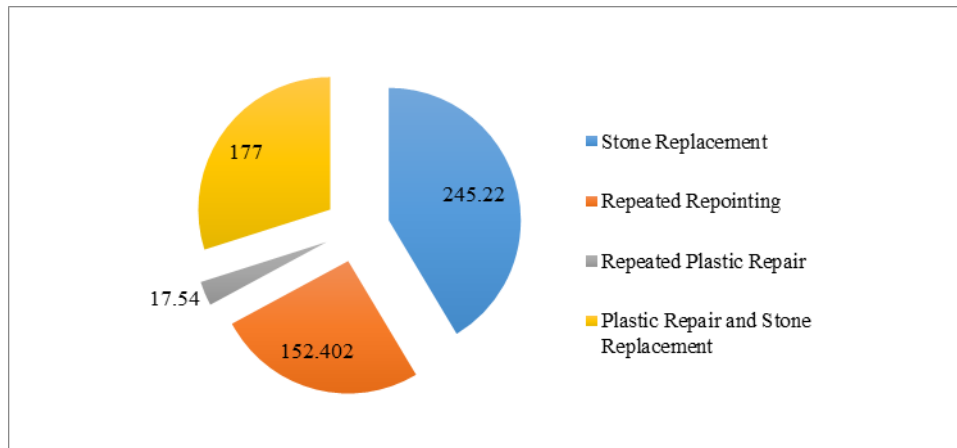
Figure 11: Total generated EMI in kgCO₂e/t/m² for external wall surface area of St Paul's Church

(kgCO₂e/t/m²) and practically applies to small scale of maintenance project. Therefore, the value of functional unit will be utilised in calculating the Total EMI of St Paul's Church by multiplying it with total external wall surface area (616.52m²) of St Paul' Church (see Figure 11).

Figure 11 and Table 4 evidently shows that stone replacement (Scenario 1) has the highest embodied carbon expenditure either in 1m² and the Total Generated EMI over the wall surface (0.421 kgCO₂e/t/m² per 1m² and 245.22 kgCO₂e/t/m²) over 100 years of arbitrary maintenance period. Meanwhile, the results also revealed that repeated plastic repair had a small amount of CO₂ emissions (17.55 kgCO₂e/t/m²) compared to other repair techniques. However, it must be noted that the area of deteriorated wall surface is the important variable that need be considered as the higher the areas need to be re-plastered, more material is required. Subsequently, this situation will lead to high CO₂ emissions in a long run. Additionally, it is found that cement-based materials were introduced in the plastic repair technique. In which, they are generally cheaper than lime materials but it is technically incompatible and limits the longevity of repair. In practice, usage of plastic repair technique needs further intervention (e.g. stone replacement) due to its low longevity and lead to a further contribution of CO₂ emissions in 100 year (see Figure 11). Based on the Total Generated EMI in Figure 11, it also revealed that repeated repointing contributes to second highest amount of CO₂ emissions (152.402 kgCO₂e/t/m²) but it has a low initial embodied carbon per functional unit of 1m². The huge amount CO₂ emissions contributed by this technique shown in Figure 11 were mainly due to the large surface area of deteriorated and quality of workmanship (50-100mm thickness of depth). This variable requires a substantial amount of lime mortar and will lead to high amount of CO₂ emissions.
